City of Norwood, Payneham & St Peters

Renovation

Norwood Oval Fountain

NORWOOD OVAL FOUNTAIN

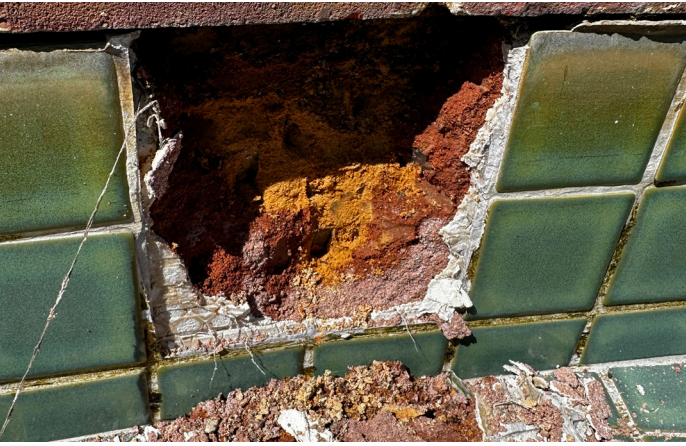
In recent times, the hedging plants surrounding the fountain had suffered irreversibly from waterlogging due to potential leaks in the base of the fountain which was causing the garden beds to flood with chlorinated water. While soil testing occurred to investigate the suitability of replanting the garden beds, our investigations of hydraulic issues discovered that while the hydraulics were working as anticipated, the pipe penetrations were the potential cause of the leaking.

Images clockwise from top left: removal of one of the lion head nozzles shows inadequate waterproofing behind the lion heads, potentially contributing to the leak; the tiles all removed from the internal fountain surface ready for grinding and new epoxy self-levelling compound; a Hydrilla banner proudly displayed outside the project site.

Corrective works included demolition of the tiling in the base of the fountain, pressure testing and visual inspection of all the pipework and penetrations, hydrostatic testing of the structure before reinstallation.

The glue and grout around the original mozaic tiles in the base of the fountain was cementious - a very common product created with a formula of cement, sand, water and specialist additives. Due to the age of the fountain structure, our team decided to replace the cementious products with an epoxy equivalent. Epoxy products are stain resistant, more durable and resistant to shrinking, cracking or crumbling, and help to create another layer of waterproofing. An epoxy self leveling compound was used to create a robust and waterproof membrane, followed by epoxy glue and grout to seal the tiles.

As part of the corrective works, the lion's head water nozzles around the inner perimeter of the fountain were removed for safe keeping. They were mounted on slate which couldn't be saved as part of the initial demolition. However, they were matched very closely to local slate from Willunga which was hand picked to best match the original stone.
