**LOCATION**  
Renmark, South Australia

**CLIENT**  
Renmark Paringa Council

**CATEGORY**  
Redevelopment

# Alan Coulter Recreation Centre

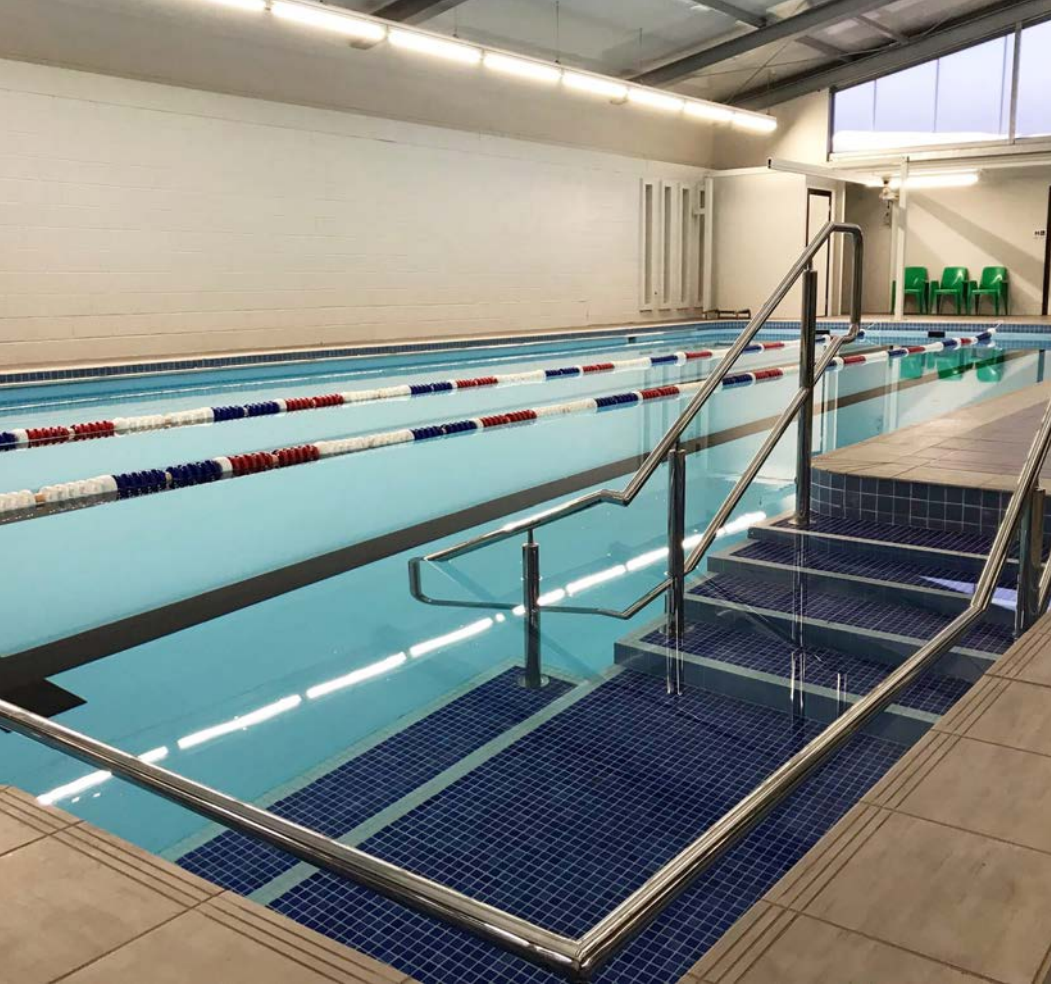
The existing pool had limited entry and exits points with an outdated and dangerous disability winch the only option for anyone with physical limitations to enter and exit the water. Old tiles and grout looked patchy and signs of cracking and lifting had begun to appear. The pool was in bad shape and was not inviting for anyone to use.

Our on-site works centered around converting an old Spa section of the pool to stairs for increased accessibility, a challenging task, which saw the demolition of the old spa and new concrete steps formed and tiled to seamlessly match the existing waterline tiles. Space constraints prohibited the construction of a ramp, however, the finished stairs and handrails do provide much-improved access for users.

Another area of concern for users of the pool was the existing paving being slippery and an old uneven surface. We updated the concourse area surrounding the pool, with new coping tiles and paver's, it not only updated the look of the pool deck but it provides increased safety for anyone getting in or out of the water. Updates and improvements were made to the skimmer system ensuring the quality of water is maintained to Australian Standards.

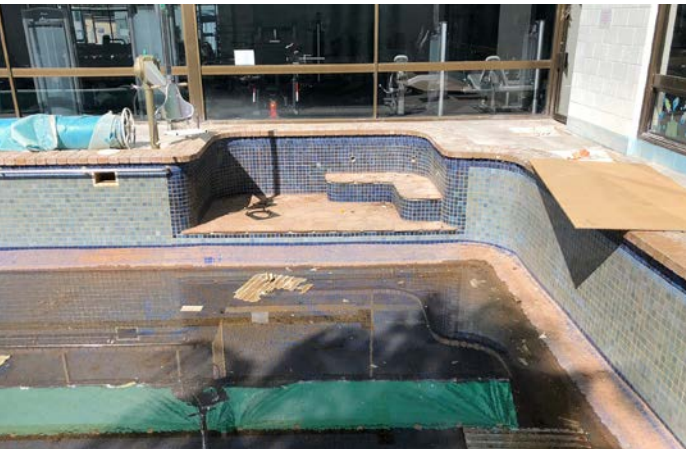
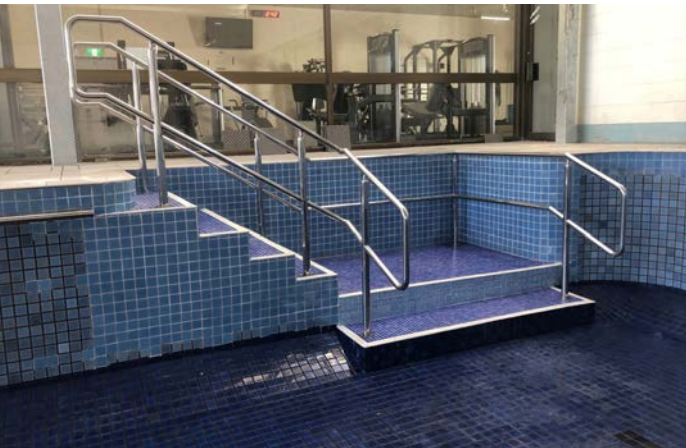
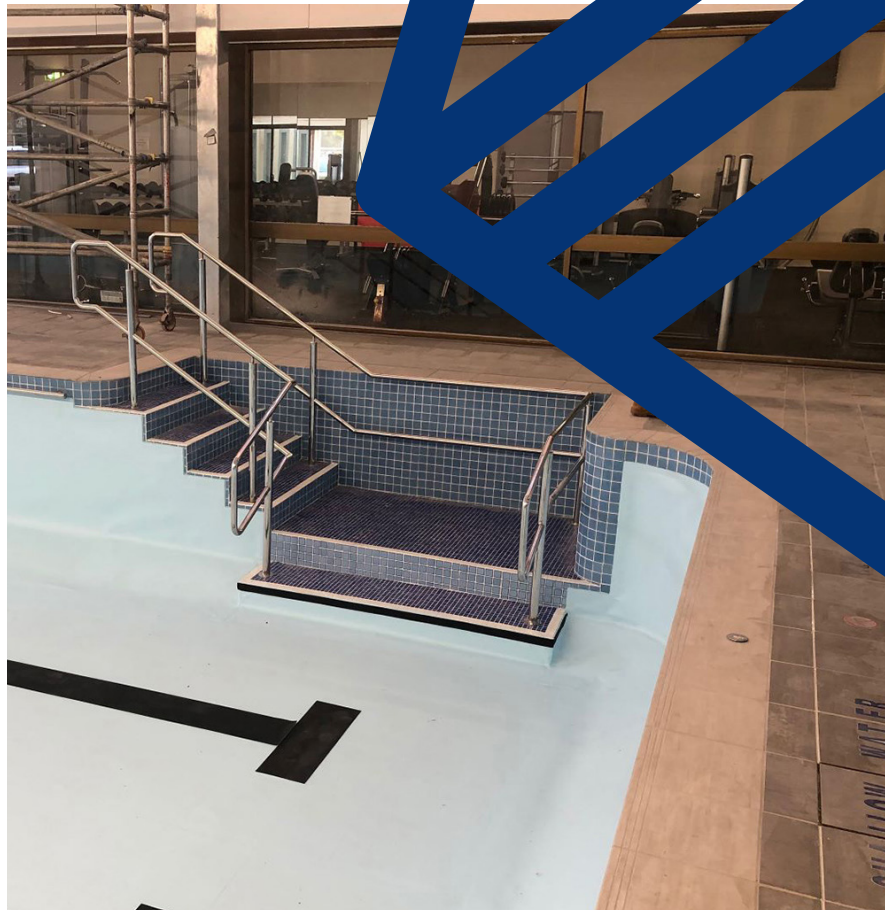
The most visually dramatic change to the pool itself was the installation of a PVC liner, installed over the existing tiles. This type of liner used has been specifically developed for commercial pool environments. Installing a liner is a cost-effective option to support older pools, it acts as a waterproof structure, flexing with the pool shell and reducing on-going maintenance requirements such as filling cracks and replacing tiles. The liner was thermally welded to ensure it fitted like a second skin providing a completely waterproof surface. The PVC liner offers additional benefits for bathers in that the non-abrasive surface creates grip and helps to prevent scrapes and cuts.
