Glenelg, South Australia

Renovation

## Oaks Glenelg Liberty Suites

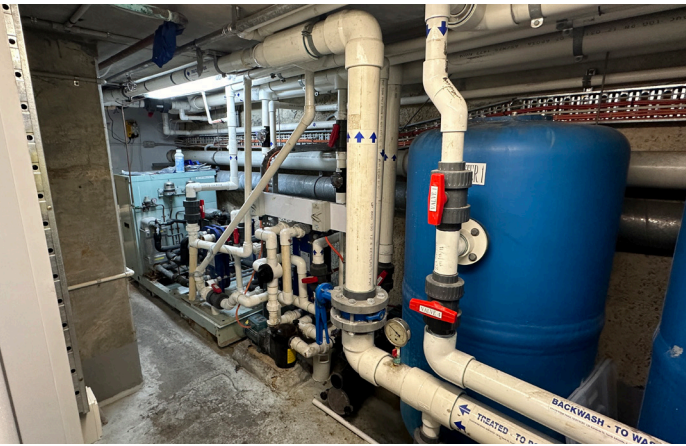
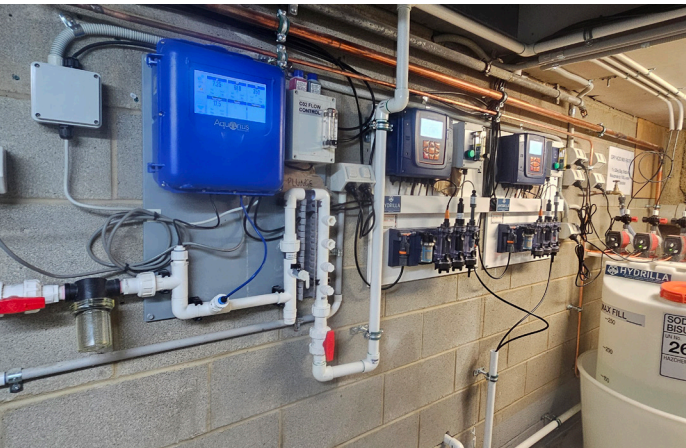
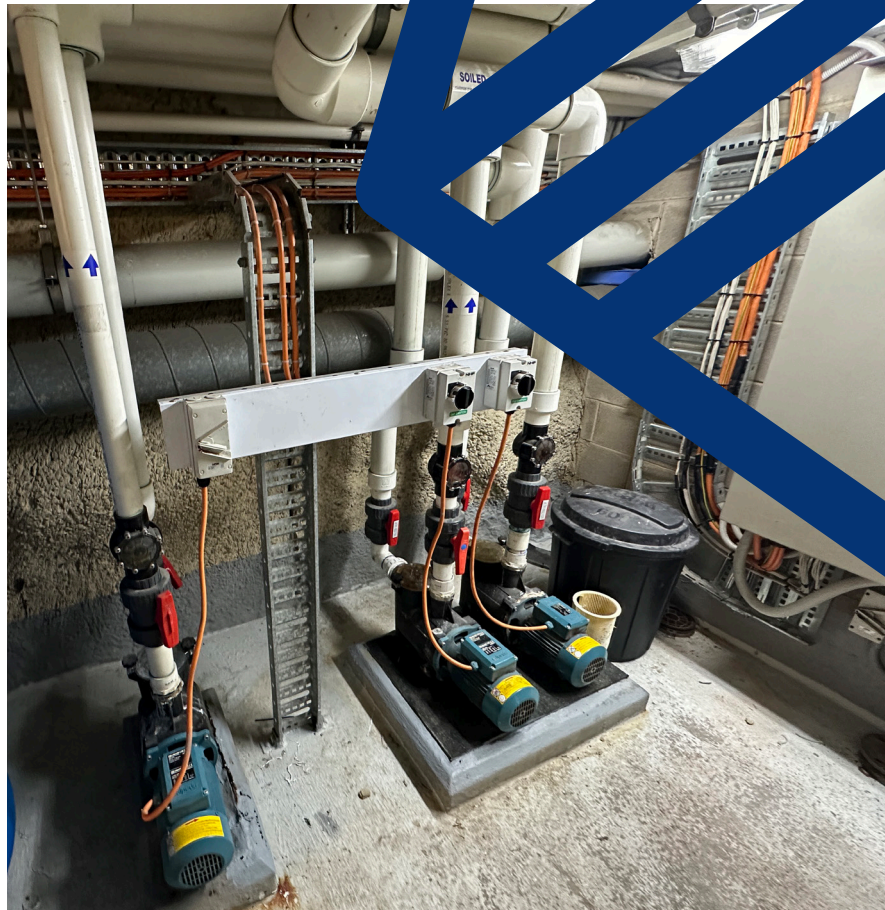
Upon removal of the equipment that had passed its usable life, concrete cancer was discovered in the plantroom floor. This was unexpected but not impossible to correct. Hydrilla contracted a specialist to fix the concrete cancer to allow for an epoxy coating to the floor which helps with cleanliness and minimising future degradation.

The installation of new and additional infrastructure into the same small space presented many challenges which our multi-disciplinary team worked through together to overcome. The additional hydraulics to complete the individual systems had the potential to create a visual knot of pipework, but Hydrilla's plumbers, with over 100 years of experience in hydraulic design and renovation found a way to make it straightforward for our client to manage on an ongoing basis. Lastly, some cosmetic upgrades to the spa and plunge pools included regrouting with epoxy grout. Previously grouted with cementitious grout, epoxy grout is more resistant to the high temperatures that occur in the spa pool.
